USDOT Tier 1
University Transportation Center
on Improving Rail Transportation
Infrastructure Sustainability and Durability

Final Report VT-6

**METHODS FOR QUALITATIVE AND QUANTITATIVE MEASUREMENT OF TOP
OF RAIL FRICTION MODIFIERS (TORFM) IN REVENUE SERVICE**

September, 2022

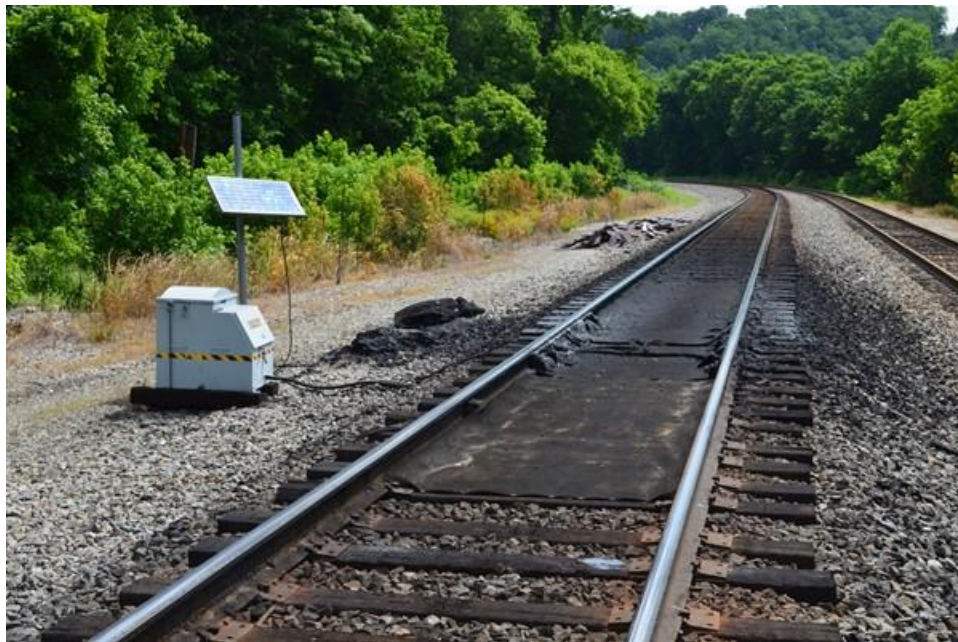
Figure 1-1: A gage face wayside applicator applies flange grease to the gage corner of the rail and the wheel flanges of passing wheels.

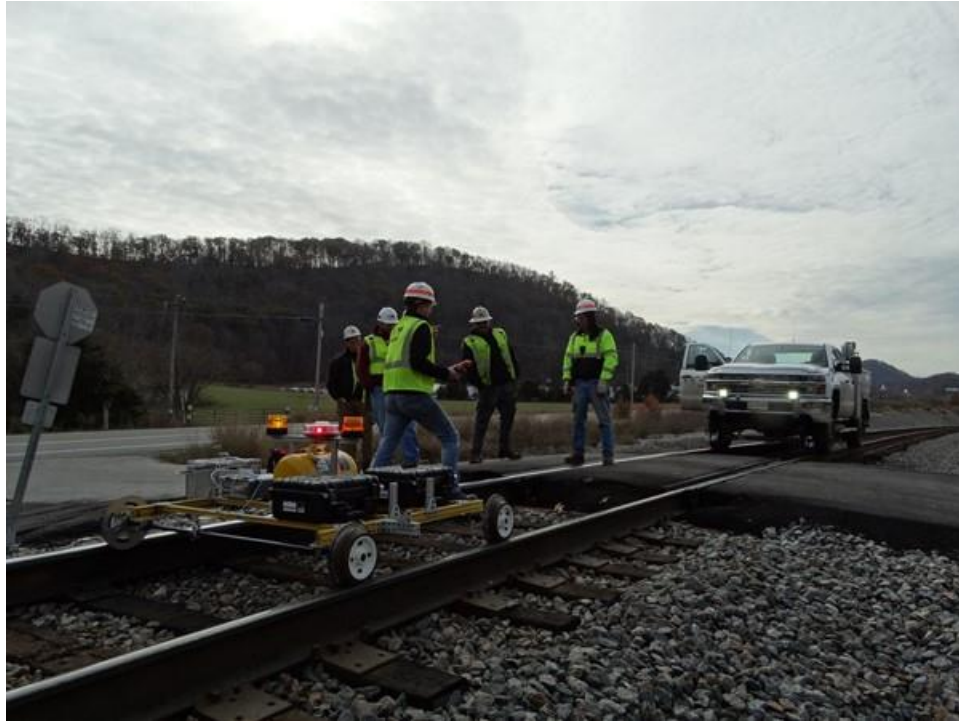
Figure 1-4: Remote Control (RC) Rail Cart and Third Generation Rail Lubricity Sensor setup on track and ready to begin field testing on revenue service track

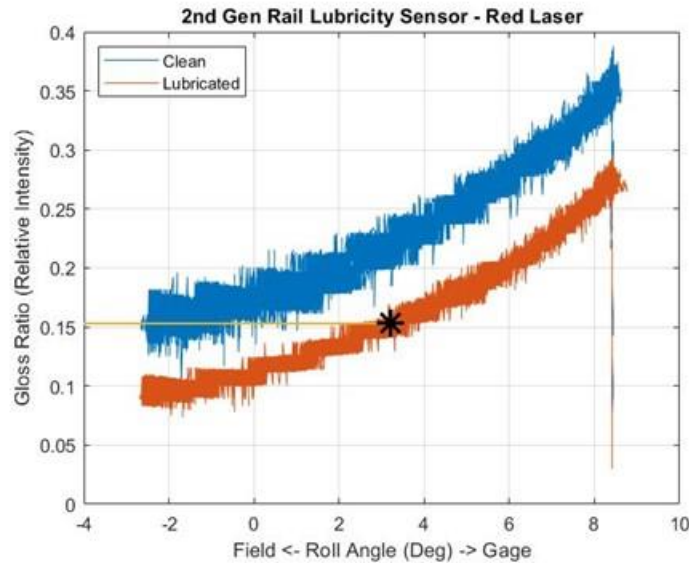
This first round of field testing revealed several key issues with the current Lubricity Assessment System. The rigid fixturing of the second generation Rail Lubricity Sensor to the push cart proved to be a challenge when it came to the changing rail surface normal. As the track would shift from tangent track to spiral and curved track, the local wear angle, also called head slope [49], would change and the optical scattering would vary as a result to a greater magnitude than the presence of absence of lubricants. For the second summer 2018 field test, a new set of sensor mounts was designed and fabricated to allow for quick adjustment of the box angle. These mounts featured two concentric arcs to allow the box to be rotated while staying equidistant and concentric to the same point on the rail head. Even so, the time constraints of the track authority window coupled with the slow rate of traversal while walking strongly limited the ability to make frequent enough adjustments [4]. It is understood that this field test data has inconsistencies in different sections due to the change in head slope. A laboratory test below shows the strong signal variance as the roll angle of the device changes. The yellow line shows the point where the two signals overlap and become ambiguous for the tested laboratory condition [51].

Figure 3-4: Gloss Ratio vs Roll Angle for different rail lubricity conditions demonstrating ambiguity due to roll angle [51]

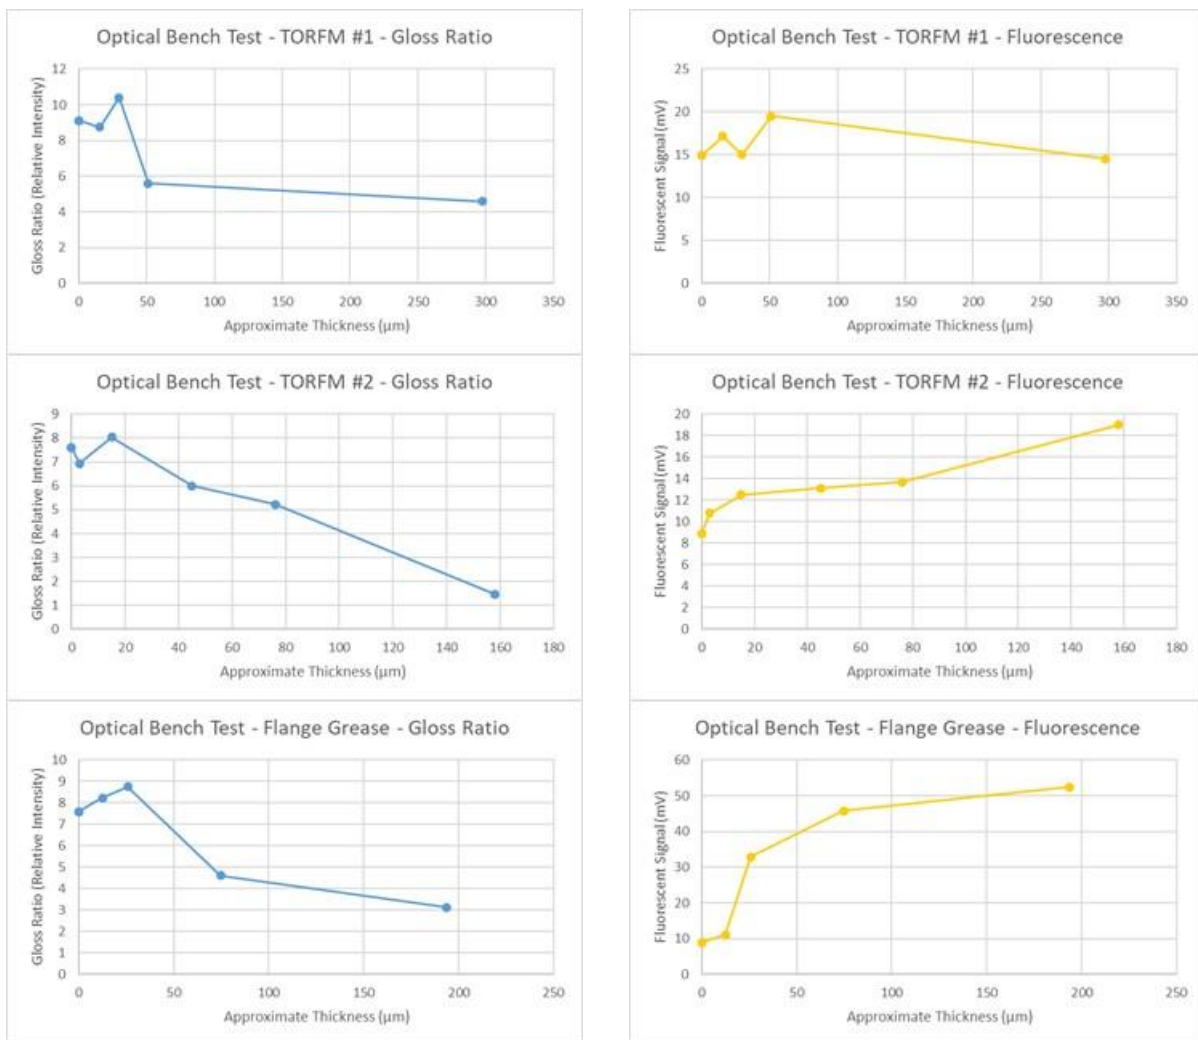
These tests were all static tests and the results were compiled into an internal CVeSS report, the results of which are also recorded here. Using an optical probe, a measurement of a cleaned rail condition was measured and compared with the measurements from different lubricated conditions. This allows for the estimation of an approximate material thickness with the understanding that the surface roughness variation is significant with respect to the material thickness making an absolute thickness measurement impossible. Instead, an approximate estimated thickness is imposed on the x axis allowing for a rough quantification of the general material thickness compared to optical response [53]. The optical bench tests demonstrate that there is a response in the gloss ratio between a clean rail condition and one where an opaque lubricant has been added to the surface. The different fluorescent plots demonstrate the fluorescent behavior of the 3 tested lubricants. The flange grease and TORFM #2 fluoresce more than TORFM #1 does but the fluorescent behavior of any of these lubricants can aid in the detectivity of the sensor.

Figure 3-13: Optical bench tests for 3 different rail lubricants

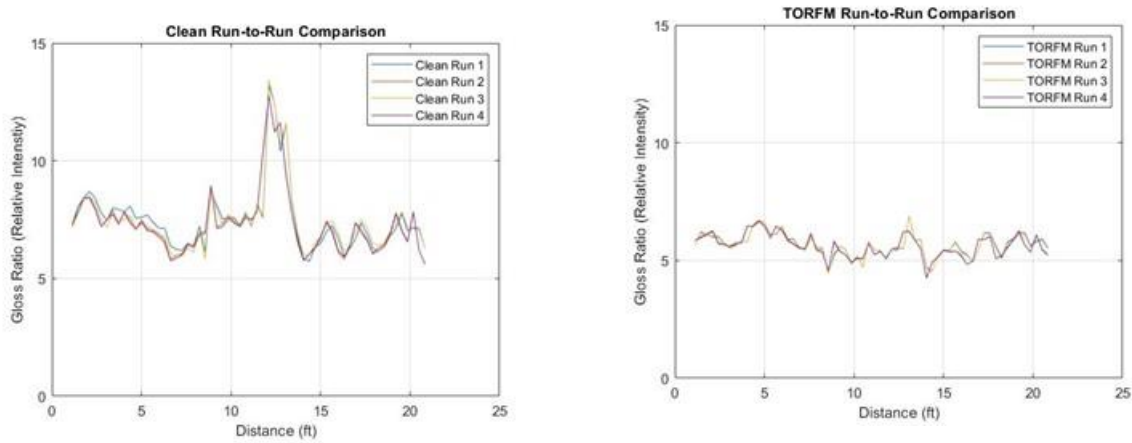
from one clean condition to the next. This shows that the cleaning process is consistent and repeatable and the sensor is likewise repeatable.

Figure 3-15: Run-to-run repeatability evaluation for clean and lubricated condition

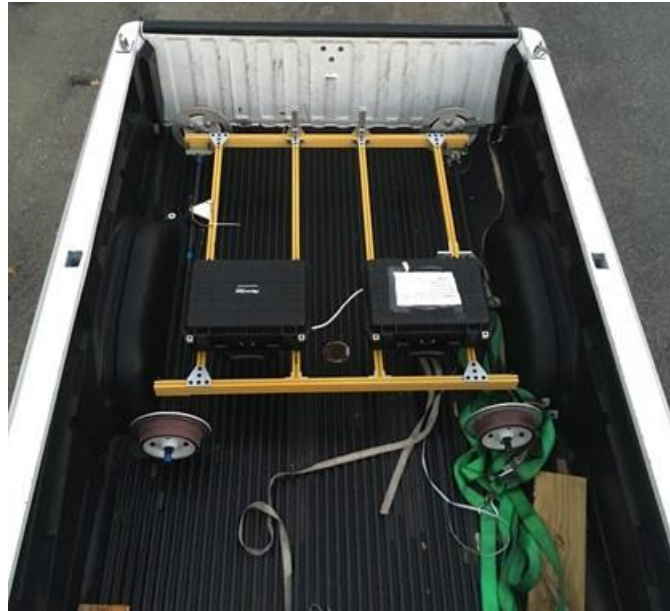
rough service roads to get to the testing site and removes the need to do any onsite assembly prior to the test. Upon arriving at the test site, the cart can be removed from the bed of the truck and set on the track immediately ready for testing.

Figure 4-2: Test fit of remote control rail cart in the bed of the lab pickup truck

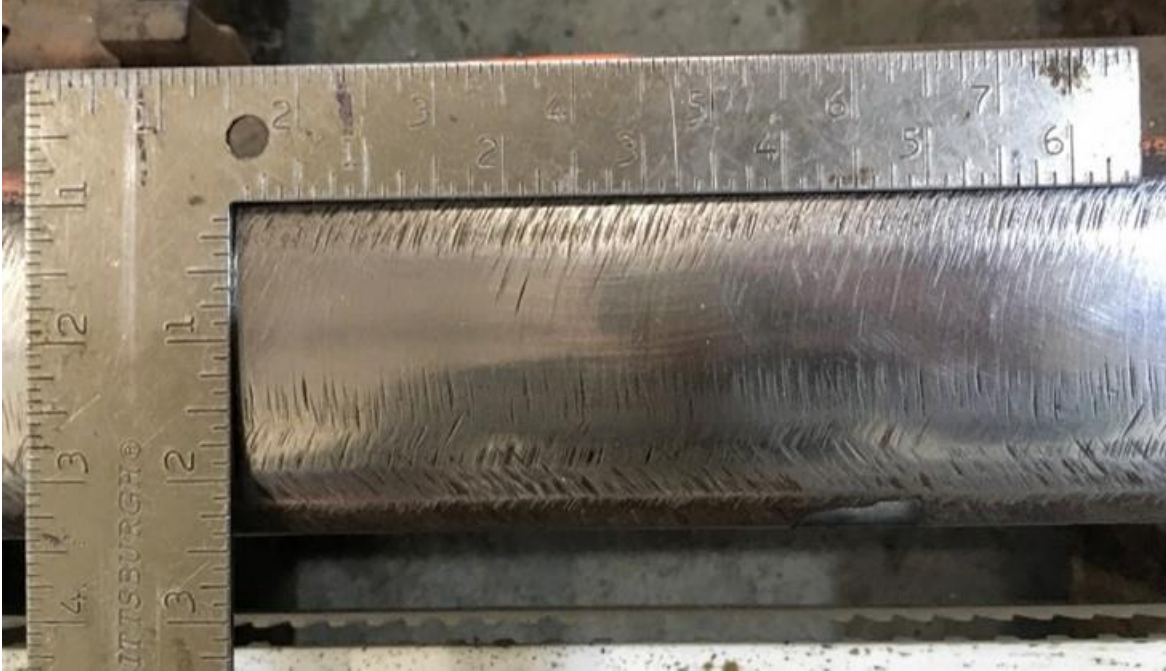
Small localized spikes in the optical channels are prevalent as the rail surface is not a uniform, smooth surface. The rail surface is very stochastic with a high amount of surface imperfections. Different angled cracks in the rail surface can sharply change the scattered power for a single sample and surface glints are common during measurements on rail surfaces. Some of these surface features can be easily visible by the human eye and some of the cracks and facets will require a microscopic view of the specimen. Because all of these features are far below the -20 dB cutoff period of 3.73 feet, the majority of the effects of these high frequency, low period effects should be strongly attenuated by the moving average filter.

Figure 5-2: Top-of-Rail Surface roughness of RTL track panel

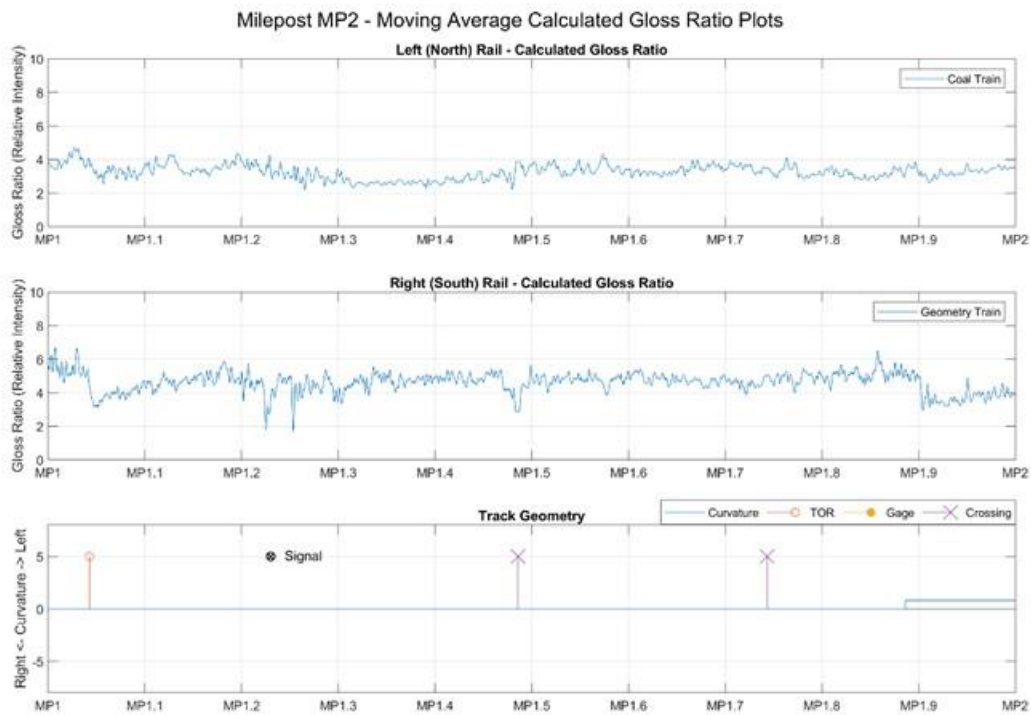
The next TOR applicator is very close to MP 1. This time the dip in CGR is prominent on both the left and right handrails as heavy TORFM is present at the wayside applicator. The CGR quickly rebounds from a heavy TORFM condition to a gloss ratio of around 4-5 which is more typical of lubricated rail. Again, the right hand rail shows a higher lubricated condition than the left hand rail from the preceding traffic. This section of rail is straight for almost a mile and after passing over the second applicator, the conditioned wheels tend to maintain their lubricity longer.

Figure 5-7: Moving Average Filtered Calculated Gloss Ratio Data from Milepost 2

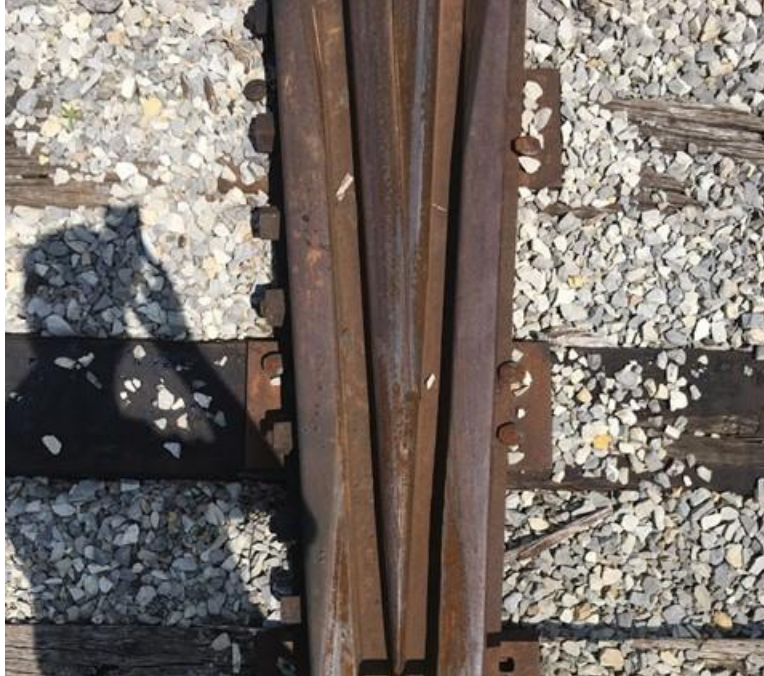
Near MP 1.2, there are a few dips in the gloss ratio on the right hand rail. At this spot there is a signal and a switch to the passing siding at Riverside. The right hand rail passes through a switch frog which allows for the diverging rails to cross and the trains to navigate from one track to the other. When the sensor goes over the switch frog, it is exposed to the rough oxidized steel surface of the frog and the gloss ratio drops for a short distance. With access to track data, it is easy to identify these anomalies and disregard the local effects caused by them.

Figure 5-8: Example of a switch frog

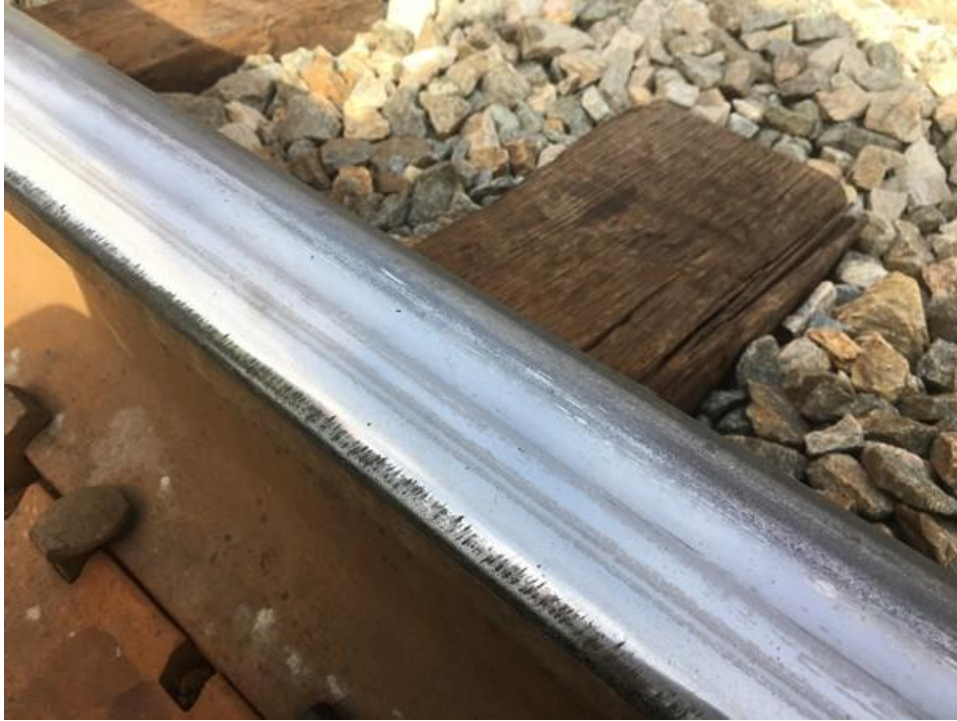
Figure 5-11: A field survey of the mainline track shows evidence of TORFM on the outside of the rail.

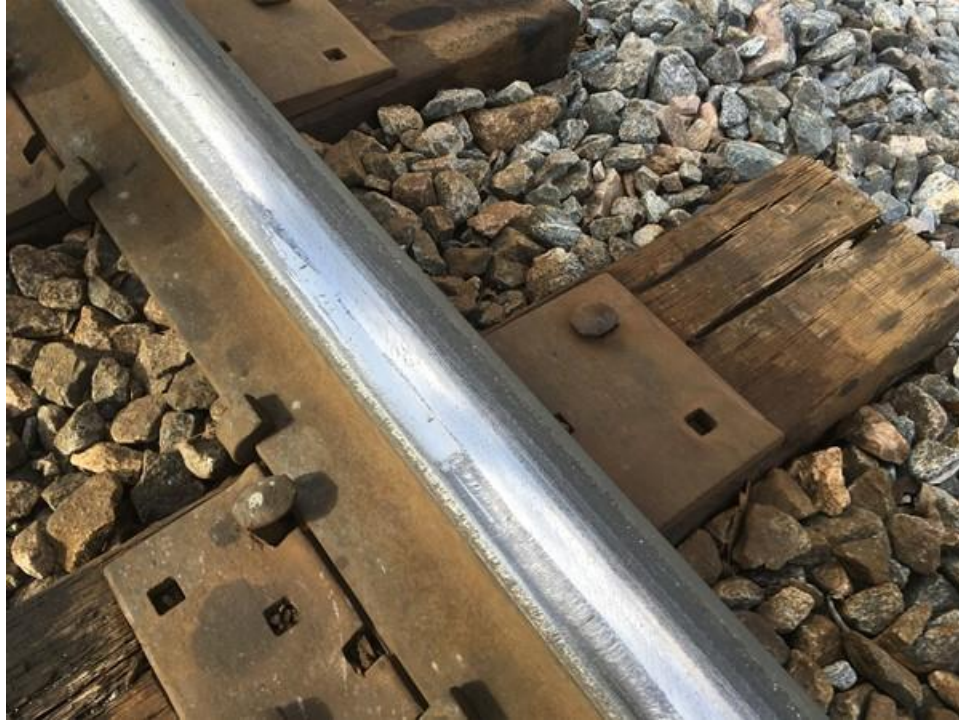
Figure 5-12: Patchy TORFM condition in a sharp left hand curve

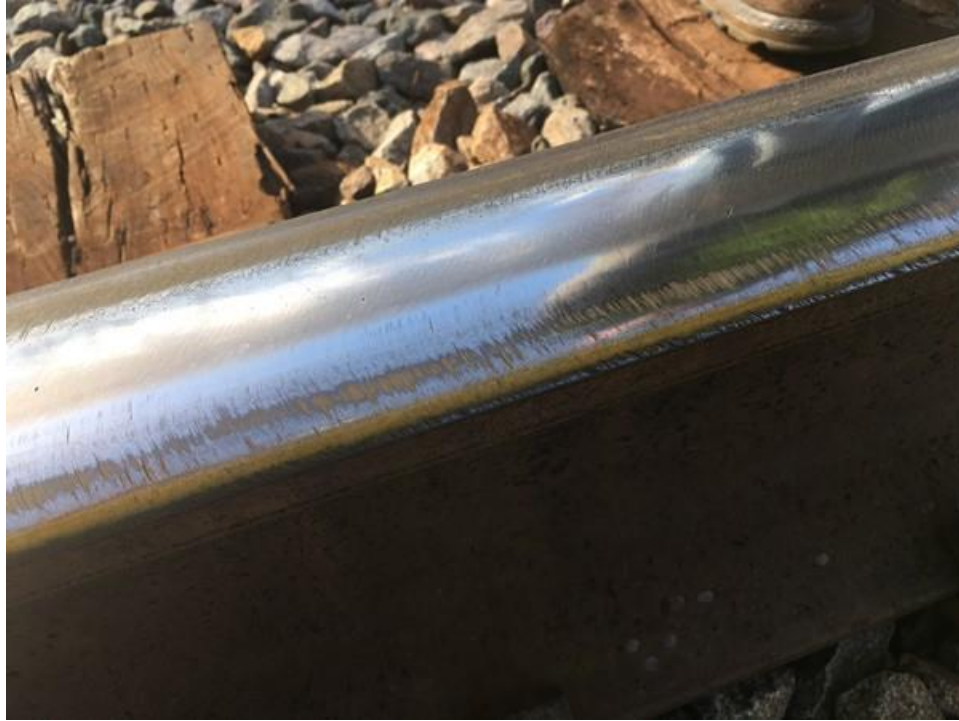
Figure 5-16: A field survey of the track near MP 3.7 shows limited signs of TORFM

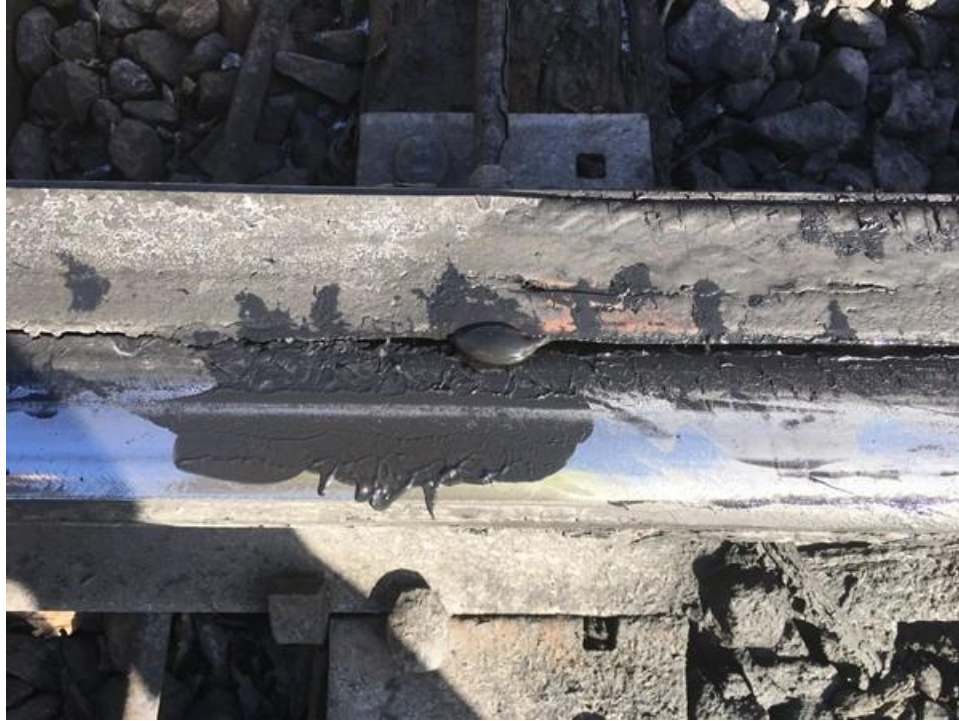
Figure 5-21: TOR wayside applicator functioning correctly in the field with TORFM applied to the rail surface.

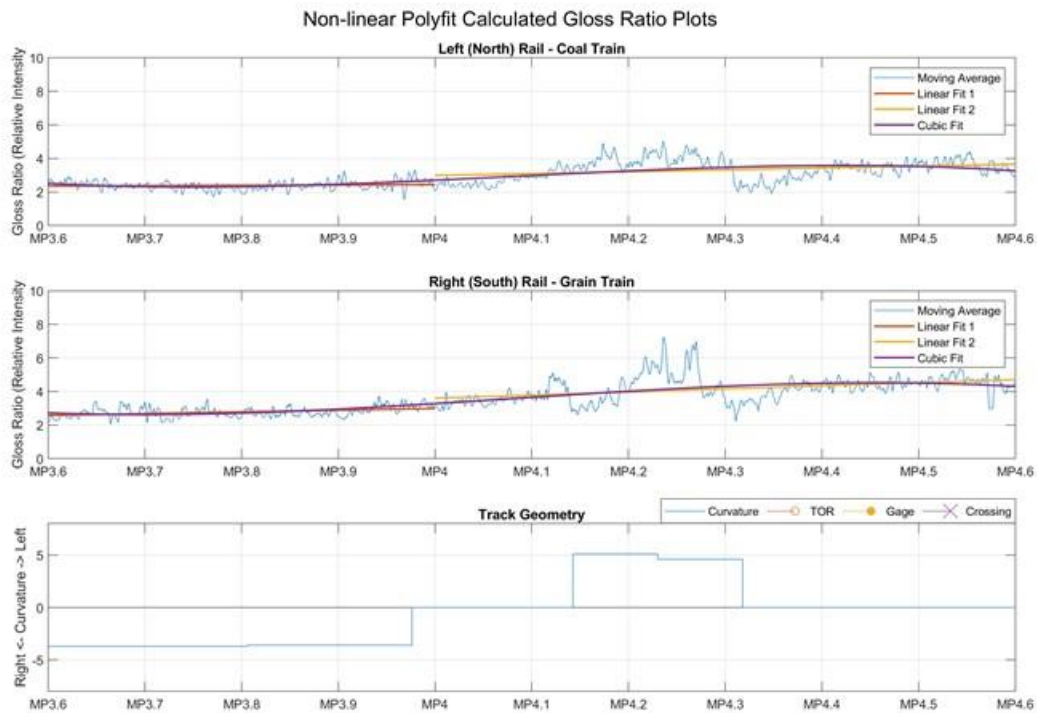
Figure 5-30: Nonlinear curve fit of Moving Average Filtered Calculated Gloss Ratio data in Mileposts 3 and 4

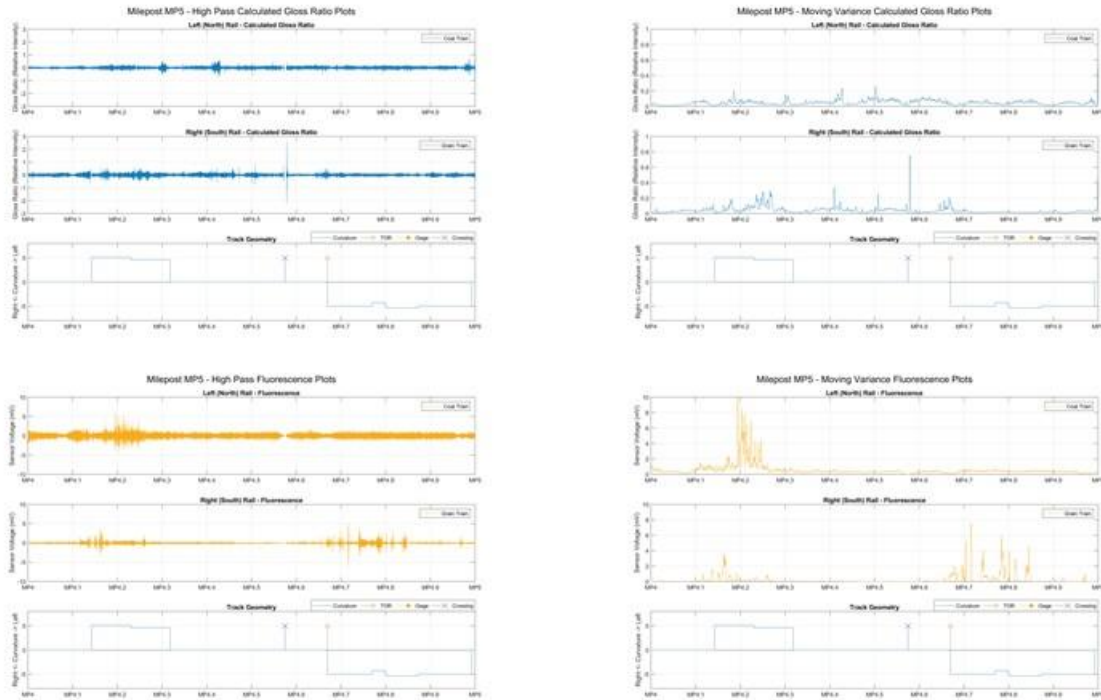
Figure 5-37: High Pass Filtered and Moving Variance Plots for Milepost 5

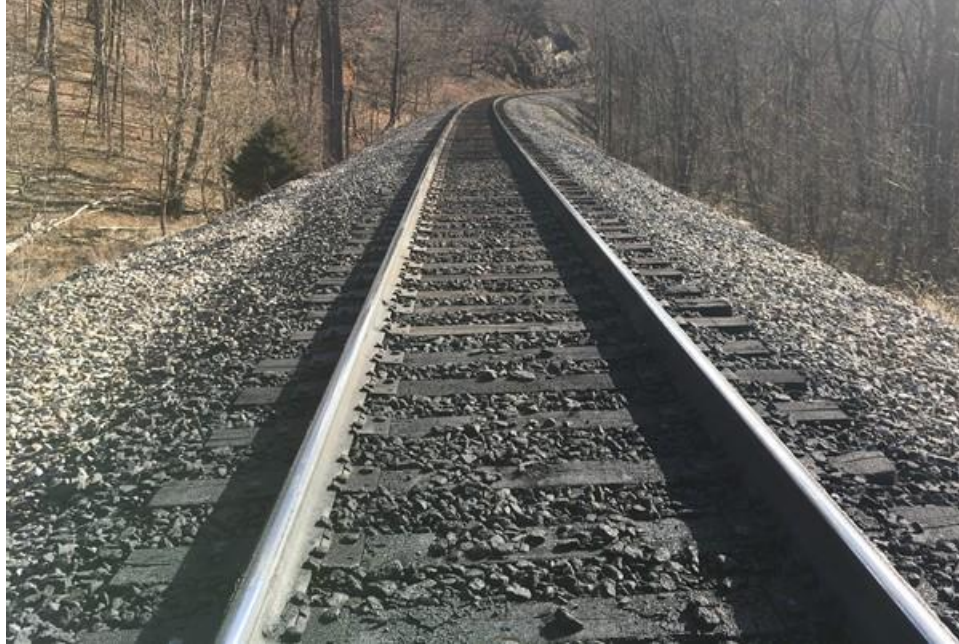
Figure 5-44: TORFM patches moving down track from a TOR applicator caused by the coherent phase of the train wheels

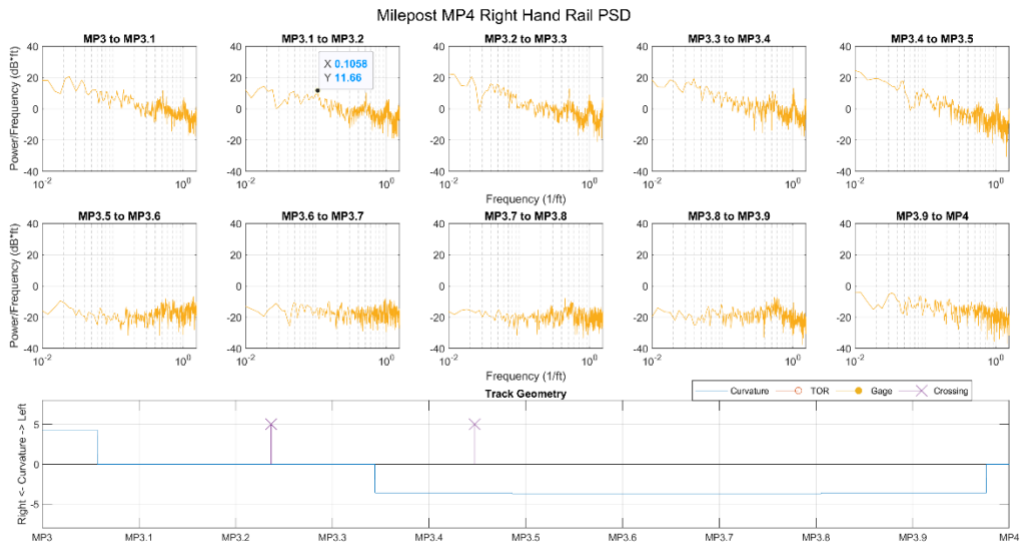
Figure 5-59: Fluorescence Block PSD Plots for the Geometry Train (MP 3 to MP 3.45) and Grain Train (MP 3.45 to MP 4) on the Right hand rail on Milepost Block 4

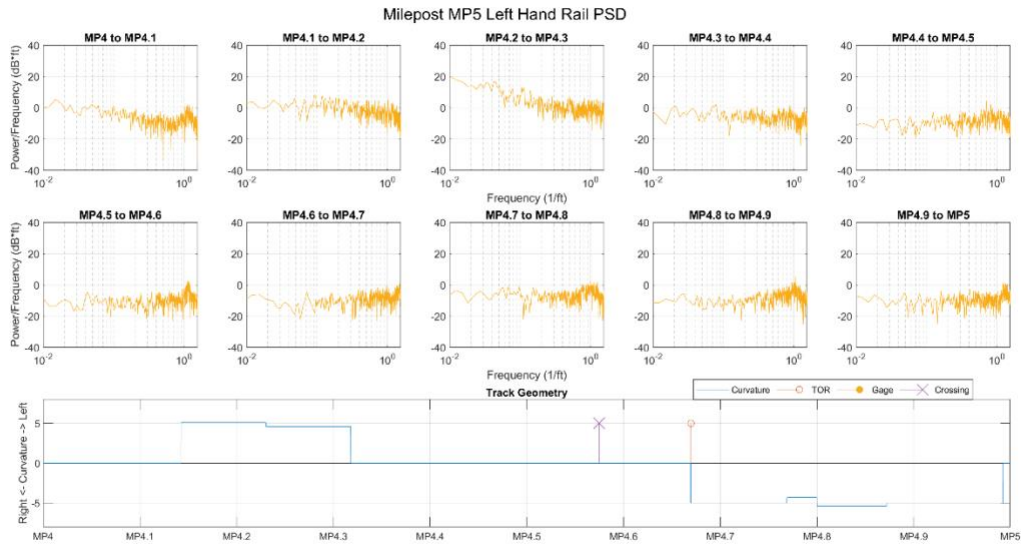
Figure 5-61: Fluorescence Block PSD Plots for the Coal Train on the Left hand rail on Milepost Block 5

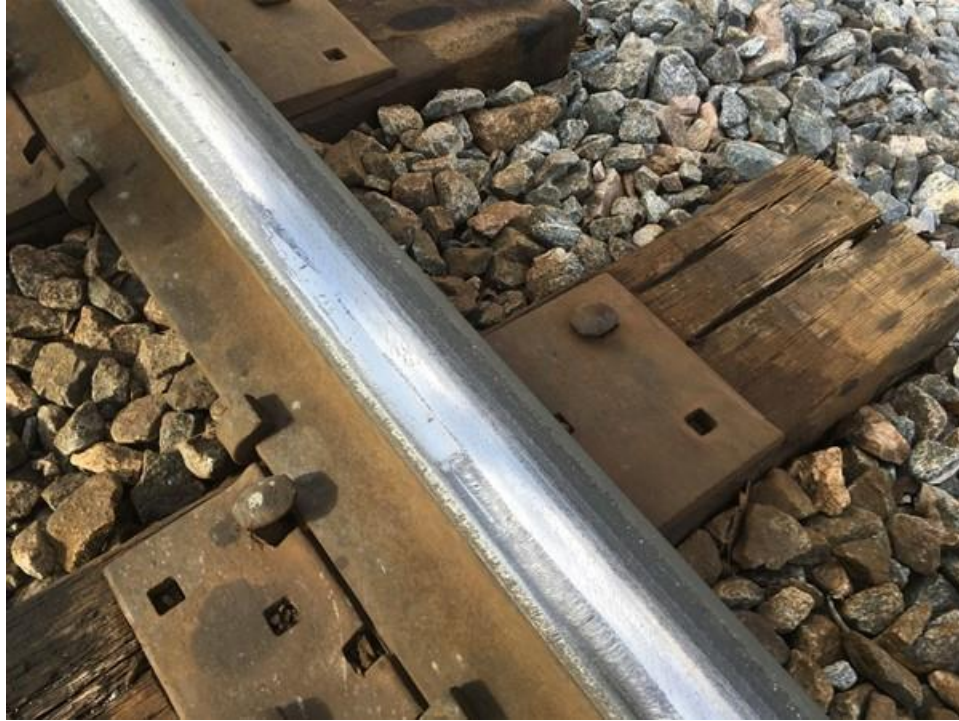
Figure 6-7: Non-uniform, "patchy" distribution of TORFM on the top-of-rail surface in a sharp curve
