USDOT Tier 1  
University Transportation Center  
on Improving Rail Transportation  
Infrastructure Sustainability and Durability

Final Report UNLV-1

**MOBILE 3D PRINTING OF RAIL TRACK SURFACE FOR RAPID  
REPAIRMENT**

September 2024

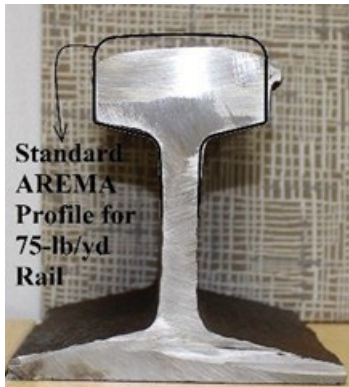
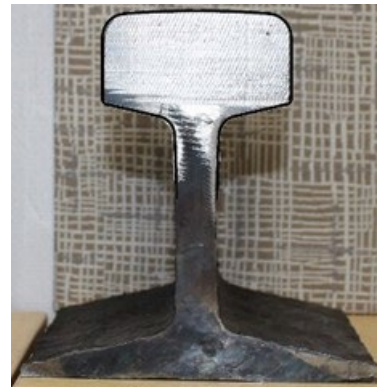
**Fig. 2.1** (a) worn light rail, (b) repaired light rail, (c) worn heavy rail, and (d) repaired heavy rail.

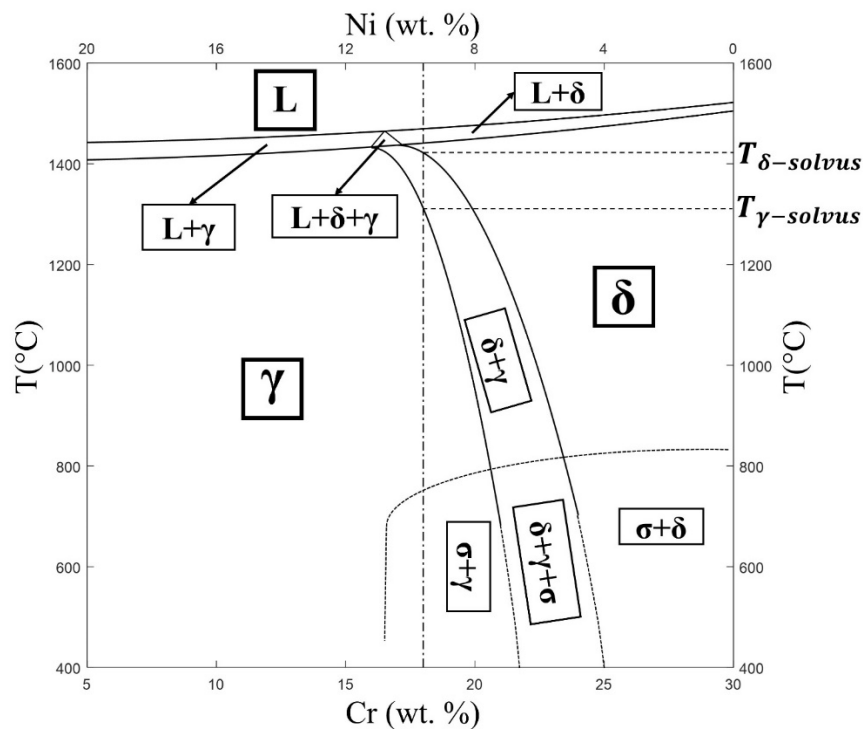
**Fig. 3.8** Phase diagram of the Fe-Cr-Ni pseudobinary system for 304L (70 wt.% Fe) used in powder form for the LPD repair process. L: liquid;  $\delta$ :  $\delta$ -ferrite;  $\gamma$ : austenite;  $\sigma$ : sigma.

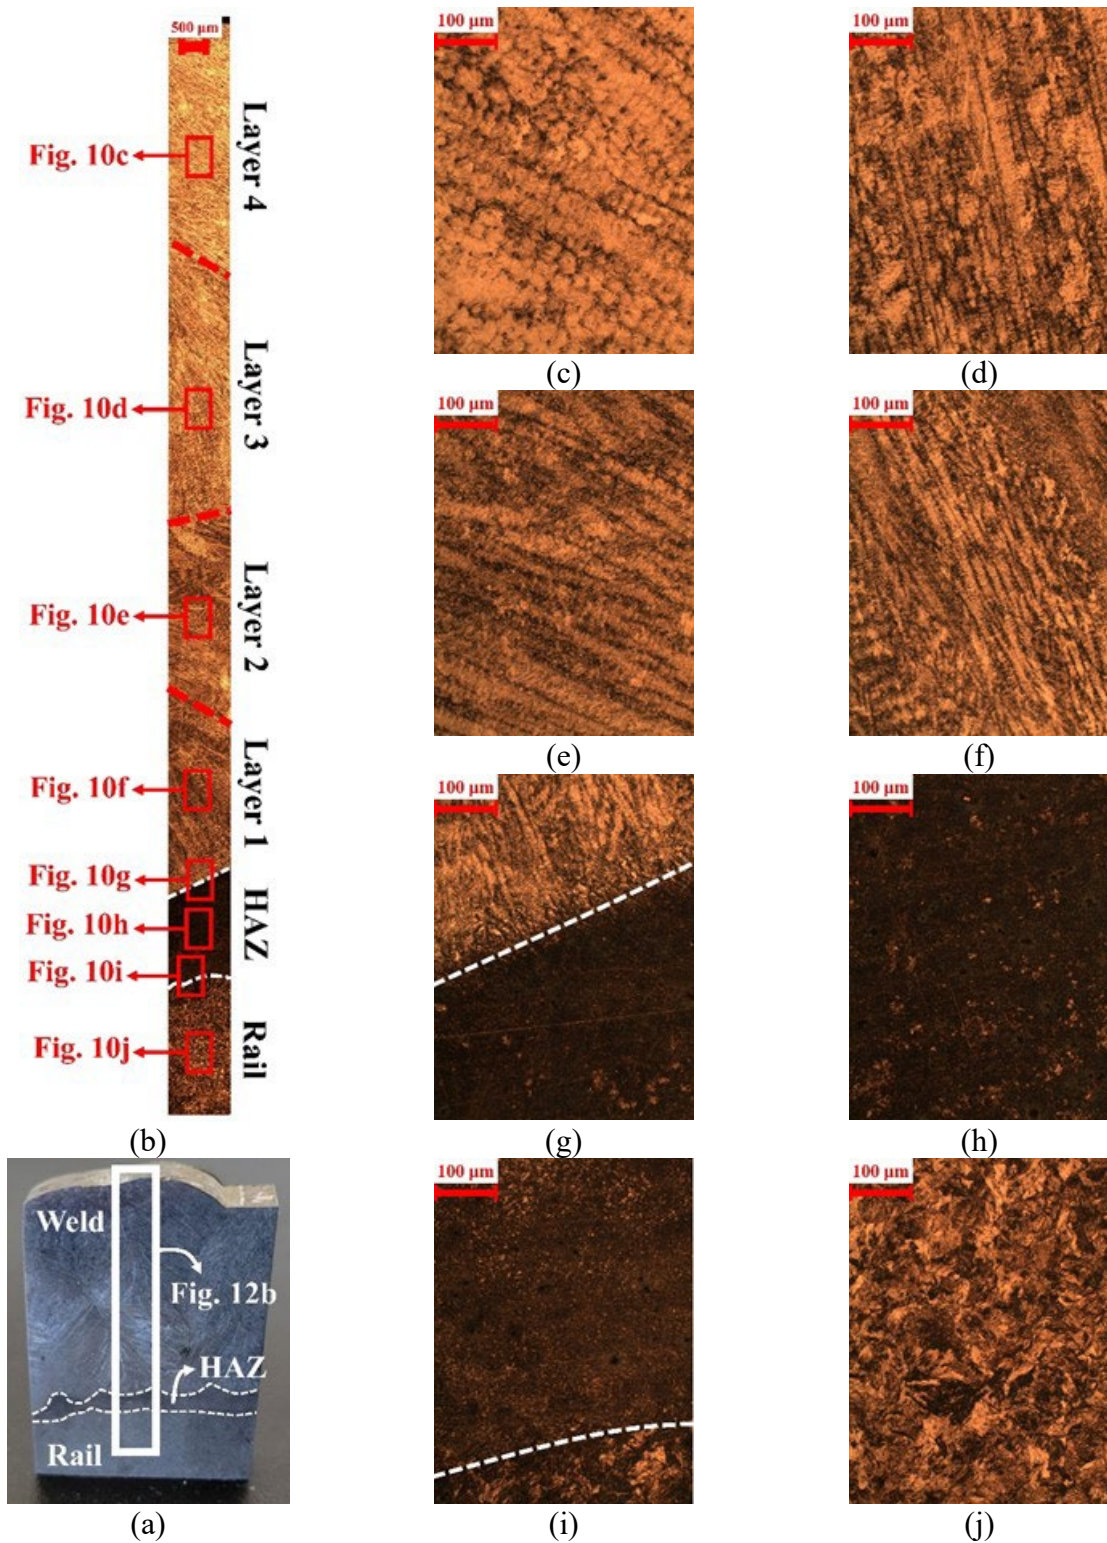
**Fig. 3.12** (a) An etched specimen extracted from the head of the repaired rail, (b) A thorough OM capture from the entire weld zone with the four layers deposited, the heat-affected zone (HAZ), and the rail; closer OM shots are taken from (c) fourth, (d) third, (e) second, and (f) first weld layers, (g) weld-HAZ interface, (h) HAZ, (i) HAZ-rail interface, and (j) rail.

A dendritic thin lamellar pearlite microstructure is detectable for the rail in Fig. 12j. The rail microstructure obviously contains coarse, light islands of pro-eutectoid ferrite and dark-etched, dendritic pearlite lamellae that are randomly oriented. Sporadic signs of dissipated carbides are also traceable over the pearlitic-ferritic matrix.

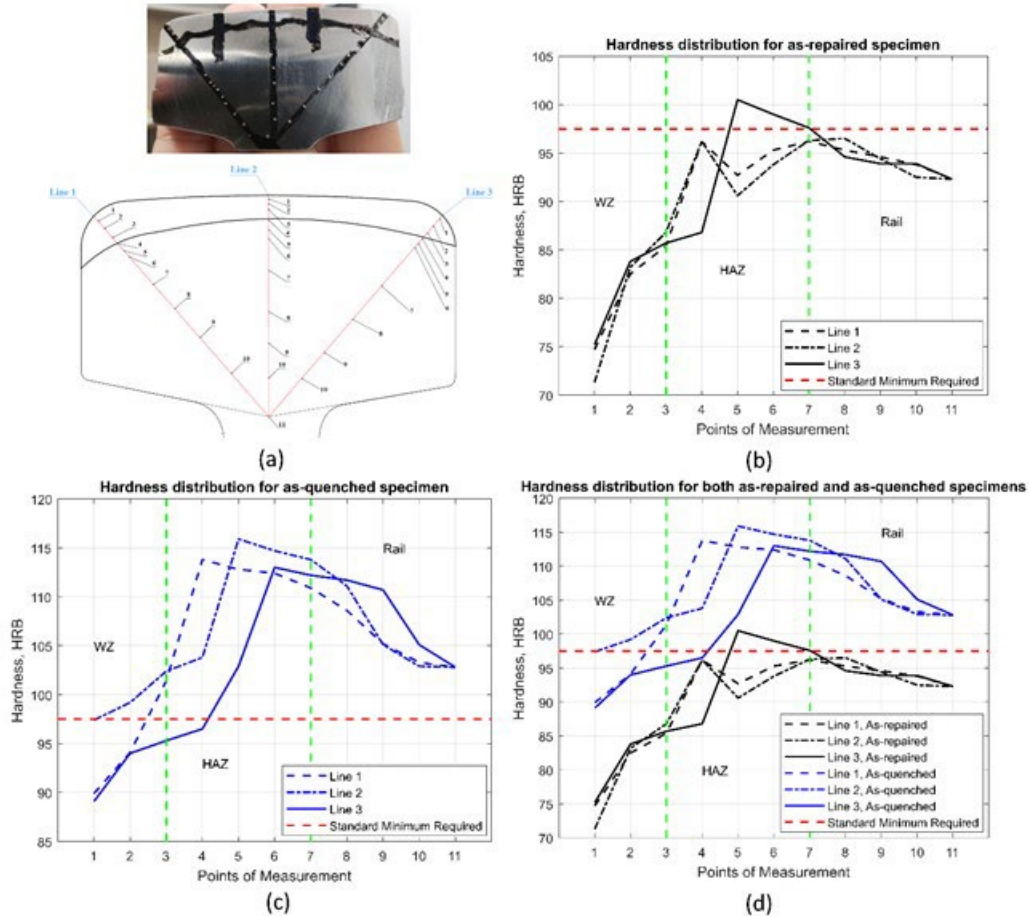
**Fig. 4.1** (a) Hardness test plan showing the lines along which hardness is measured on the demonstrated points; (b) hardness distribution for the as-built (AB) sample; (c) hardness distribution for the as-quenched (AQ) sample; (d) putting both the AB and AQ hardness distribution results together (the red dashed line represents the minimum acceptable hardness for light-duty rail, assigned according to AREMA’s standards [1]).

The hardness distribution for the as-built (AB) sample along left gauge line (Line 1), right gauge line (Line 2), and the middle line (Line 3) are shown in Fig. 1b. The minimum required hardness given by AREMA for light-duty rails [1] is also depicted as a red dashed line in Figs. 1b to 1d. The different zones of the AB rail are apparent based on the variation of hardness along the corresponding lines. The average hardness for Lines 1, 2, and 3 in the WZ area are 80.4 HRB, 78.5 HRB, and 81.5 HRB respectively. It can be seen that the gauges are slightly harder than the middle section. Similarly, the average measured hardness along Lines 1, 2, and 3 in the HAZ area are 93.1 HRB, 91.2 HRB, and 94.92 HRB, respectively. The unaffected rail substrate shows an average hardness value of 95 HRB. As it is evident in Fig. 1b, the hardness in the WZ increases gradually from top of the AB railhead down to the WZ/HAZ interface. Sec. 3.1.1, Fig. 1 shows a descending trend of austenite from WZ1 downwards to WZ3, which justifies the rising trend of hardness from top of the weld zone down to the WZ/HAZ interface. Sec. 3.1.1, Fig. 1 also presents the increase of pearlite volume fraction from WZ2 to WZ3, which again confirms the higher hardness value in WZ3. It can be observed from Sec. 3.1.1., Fig. 1 that the HAZ has a considerable finer grain structure compared to both the WZ and the rail. This fact along with the great density of carbide precipitations in this zone makes the HAZ the hardest zone among all the areas of the AB sample as shown in Fig. 1b. The coarse-grain pearlitic-ferritic microstructure of the rail zone with moderate mass of carbides gives a medium hardness value for this region. It is clearly observable in Fig. 1b that the overall hardness of the AB rail is below the minimum AREMA requirement.

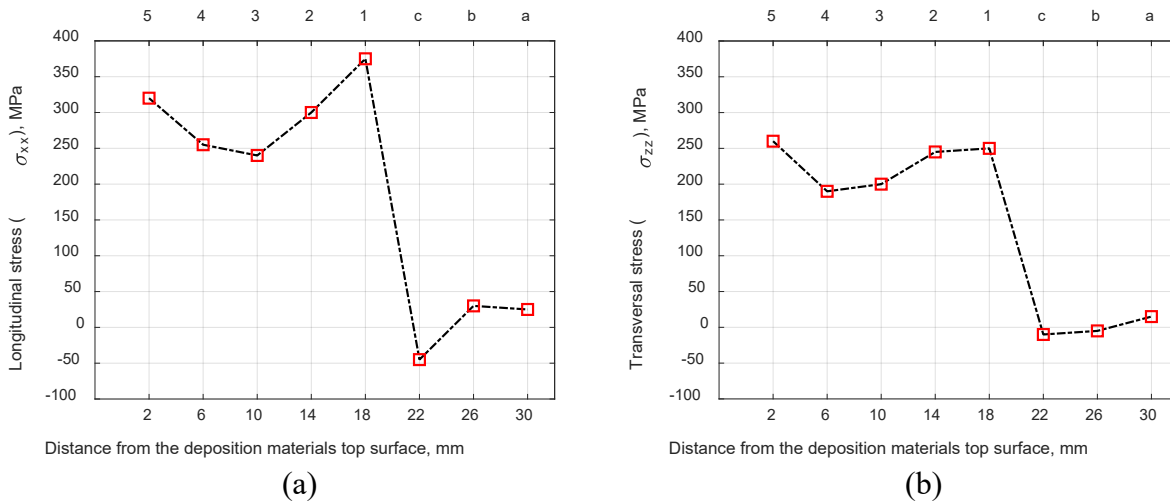
**Fig. 5.10** The XRD measured (a) longitudinal ( $\sigma_{xx}$ ) and (b) transversal ( $\sigma_{zz}$ ) residual stress distribution in the repaired rail. the upper x-axis denotes the corresponding measuring point (refer to Sec. 2.3, Fig. 5c for configuration of the points).
